## **DEPARTMENT OF PUBLIC UTILITIES**

### **PIPELINE ENGINEERING AND SAFETY DIVISION**

## **INCIDENT REPORT**

214 Lunenburg Street, Fitchburg, Massachusetts  
February 5, 2013

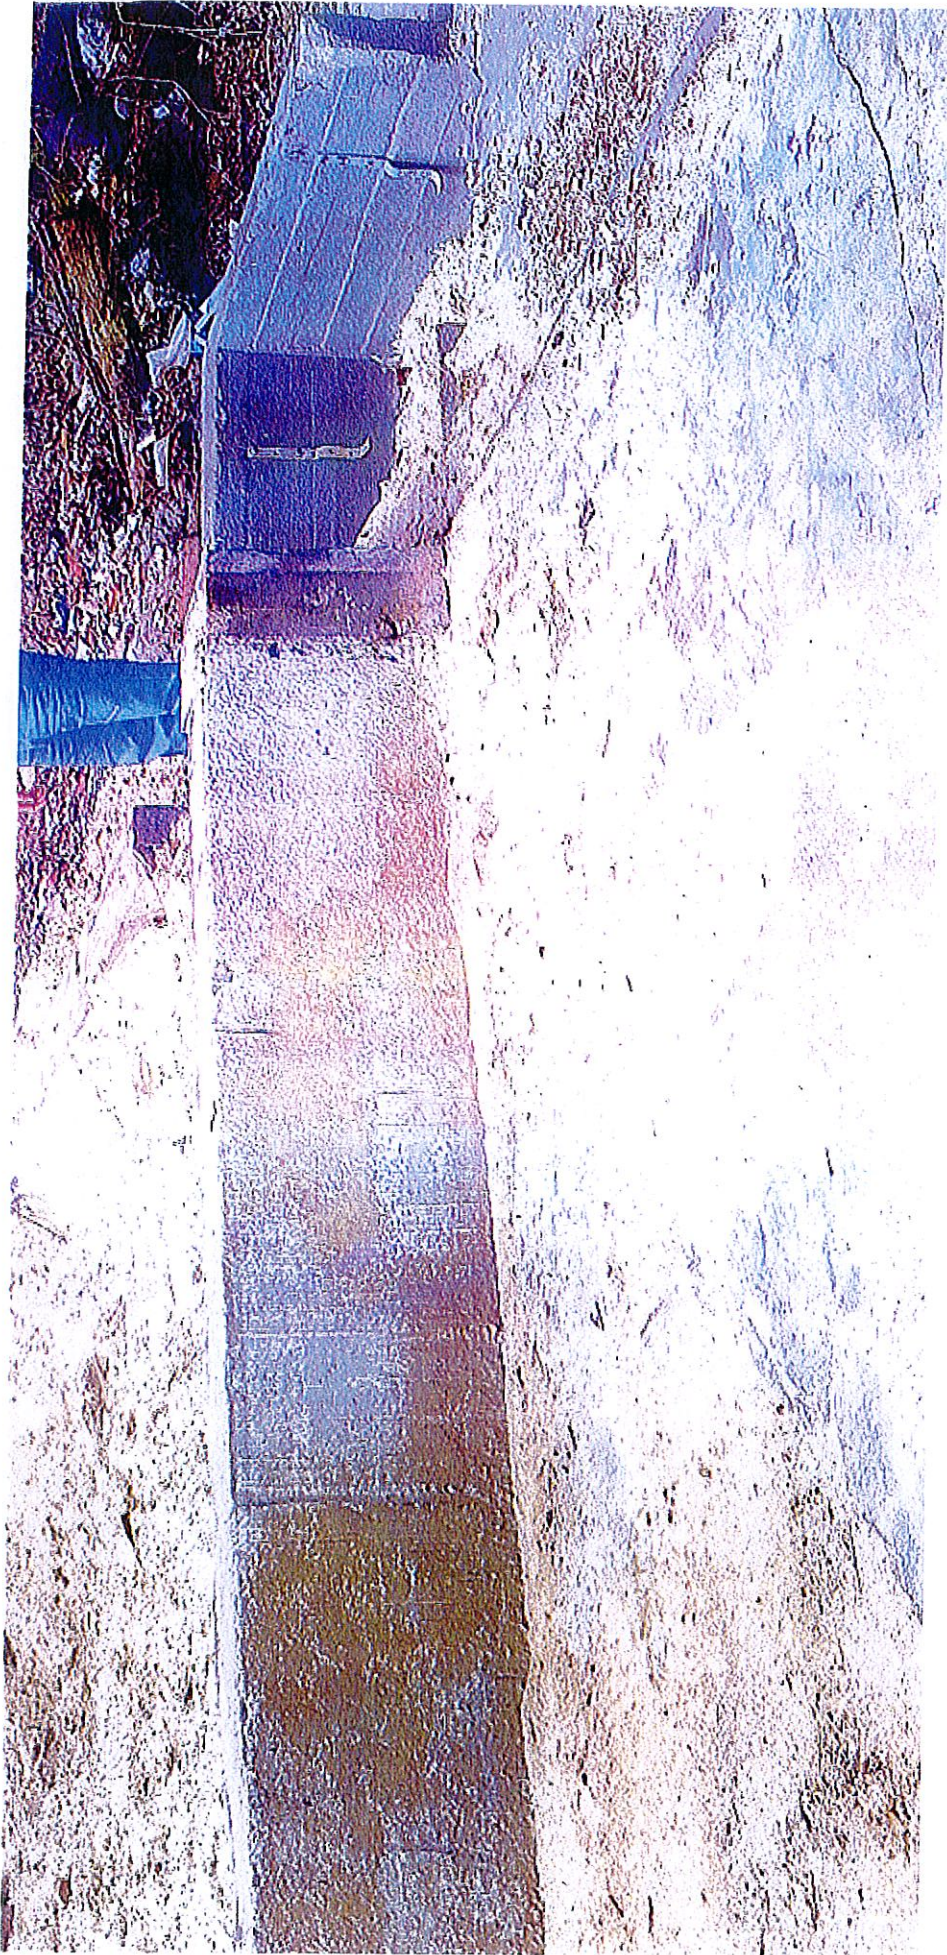
## EXHIBIT 6

- (a) the northwest corner of the foundation of 214  
Lunenburg Street, Front
- (b) foundation concrete blocks

(a) The northwest corner of the foundation of 214 Lunenburg Street, Front
